Investigation and Analysis of Lightning Disaster in a Coal mine

Abstract Based on the site investigation of a lightning stroke accident in a coal mine in Weiyuan County during a strong thunderstorm process on the night of August 10, 2024, combined with the investigation data of the accident site, the causes of the lightning stroke accident were analyzed, and the corresponding rectification suggestions were put forward.

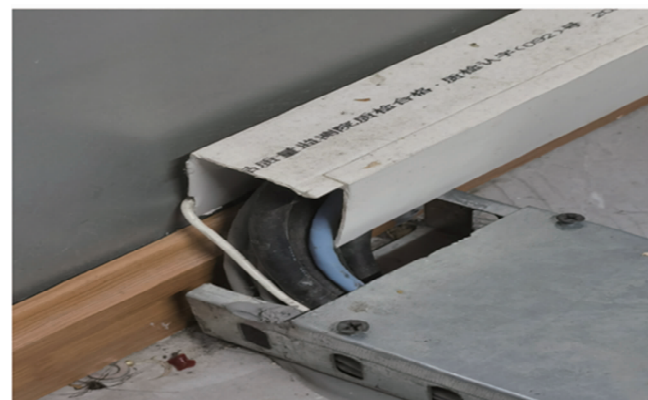
Through further inspection, it is found that in the non-metal bridge of the signal cable output from the optical signal modem, not only the signal cable is laid, but also a grounding cable for protection, a power supply cable and signal cable are in the same non-metal cable slot, while the signal cable is not shielded (Fig.1). It does not comply with the safety spacing specified in Table 5.3.4-1 and Table 5.3.4-2 in the *Technical Code for Protection of Building Electronic Information System Against Lightning* (GB 50343-2012)^[1].

Fig.1 Power cables and signal cables installed in the same non-metal cable slot non-metal cable trays

Since the power supply cables, signal cables and protective earth cables from the equipment room to the monitoring room are mixed in the same non-metal cable trough, their spacing seriously does not meet the requirements of the *Technical Code for Protection of Building Electronic Information System Against Lightning* (GB 50343 – 2012). When lightning flashes in the office building, the strong electromagnetic field generated by the lightning surge as it drains down the lead line is induced to the signal cables, protective earth cables, and power cables in the non-metal cable trough without electromagnetic shielding effect. Then, the lightning surge pulses are induced in the power supply cables, signal cables and protective earth cables, so that the lightning surge induced in the signal cables would damage the control boards of the monitors.

Based on the electromagnetic shielding principle, the electrical signal output from the optical signal modem is laid in the metal bridge, and the metal bridge should be earthed. In order to ensure the electromagnetic shielding efficiency of the metal bridge, the joint of the metal bridge should be made of equal potential jumper. According to the spacing specified in Table 5.3.4 – 1 and Table

5.3.4 – 2 in the *Technical Code for Protection of Building Electronic Information System Against Lightning* (GB 50343 – 2012), the safety spacing between power cables, signal cables, and protective earth cables should be ensured.
